# Manhole Inspection Summary

Manhole # S71E1\_016MH

**Location** Address: **6562 Parnell Ave.**

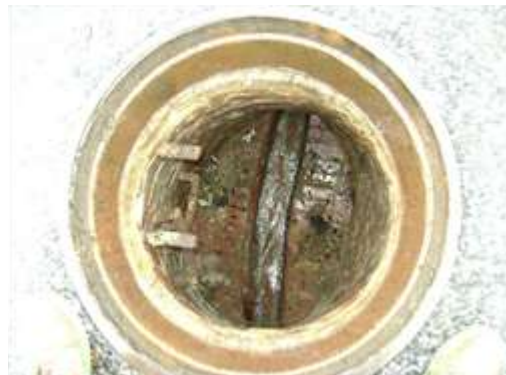
Top View

Comments **SURCHARGE DEBRIS ON BENCH.**

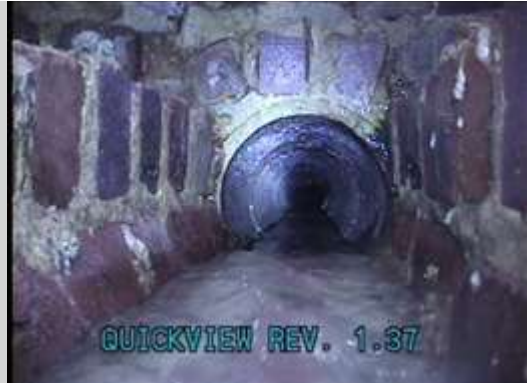
12 O'Clock Outflow

8 in. Circular Gravity Sewer  
Pipe Out @ 12 O'Clock

Pipe Height: **8.4** (in.) Rod and Bar (Angled)  
Pipe Material: **Clay** ☐ Pipe Lined  
Invert Depth: **7.25** (ft.) Flow Characteristics: **Fast**  
Deposits: ☒ None ☐ Mud ☐ Sludge ☐ Debris ☐ Grease  
Silt Depth: (in.) Deposits Extent:  
Infiltration: **None** Pipe Seal Cond: **Sound**

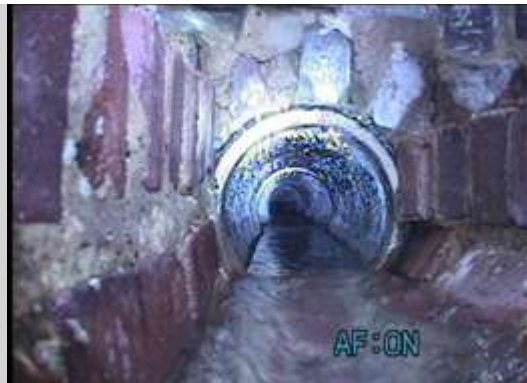
6 O'Clock Inflow

8 in. Circular Gravity Sewer  
Pipe In @ 6 O'Clock

Pipe Height: **8.4** (in.) Rod and Bar (Angled)  
Pipe Material: **Clay** ☐ Pipe Lined  
Invert Depth: **7.21** (ft.) Flow Characteristics: **Fast**  
Deposits: ☒ None ☐ Mud ☐ Sludge ☐ Debris ☐ Grease  
Silt Depth: (in.) Deposits Extent:  
Infiltration: **None** Pipe Seal Cond: **Sound**
